Freedom of Information Request

Annual

BS EN 1176 & BS EN 15312

Inspection Report

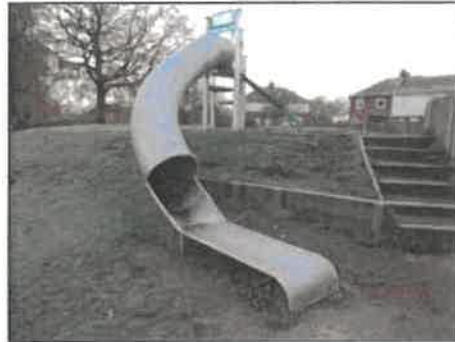
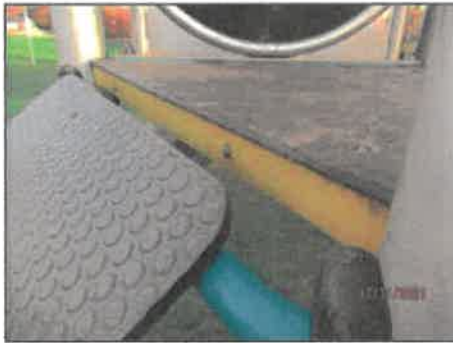
3. Sutcliffe Tube Slide

Compliance: Fails BS EN 1176-1, Sec. 4.2.7.5, foot trap between platform & top of incline climber

(Potential foot trap – library photo)

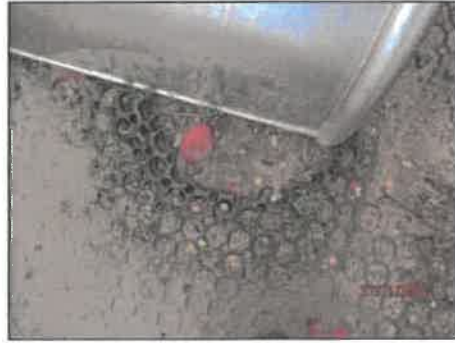
Surface Condition: Repair/replace one damaged mat at slide runout

(Damaged grass mat)

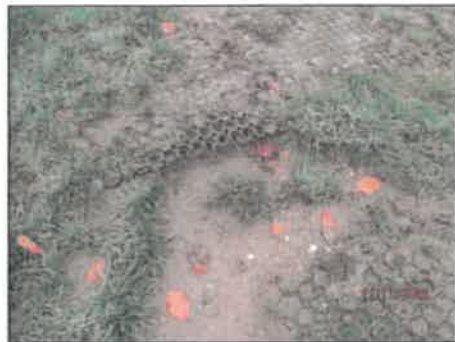
Potential trip hazards at edges of mats – requires attention
(Medium Risk)

(Potential trip hazard at edge of mat)

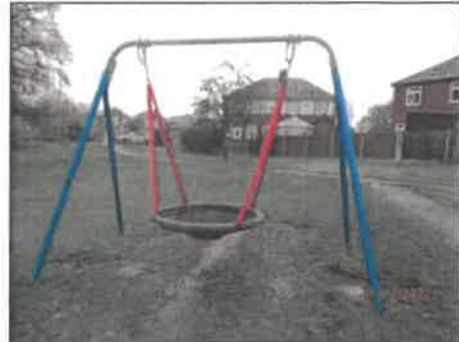
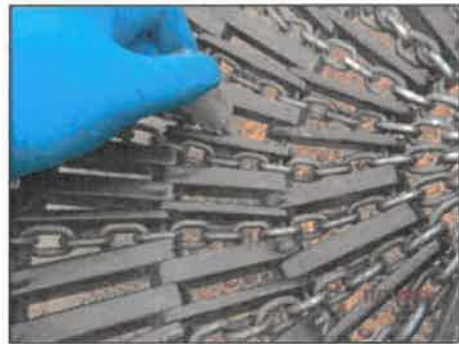
4. Sutcliffe Group Swing

Compliance: Fails BS EN 1176-1, Sec. 4.2.7.6, finger trap between plastic links on basket

Surface Condition: Grass worn (this may affect the impact attenuating properties of the mats)

(Potential finger trap – library photo)

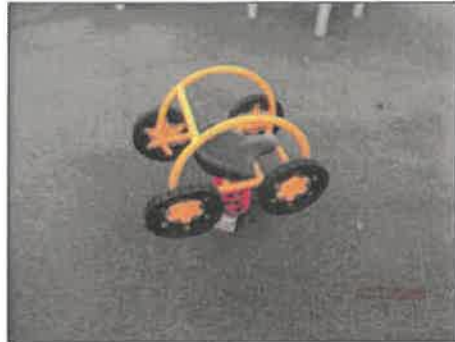
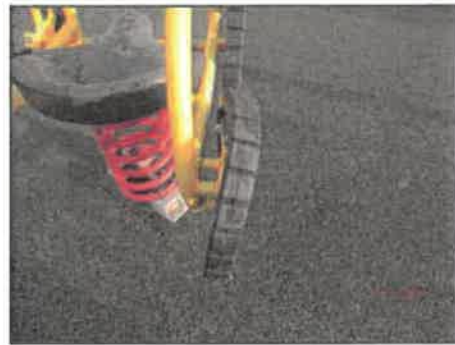
6. Sutcliffe Spring Car

Condition: Slight distortion on one wheel – monitor

(Distorted wheel – library photo)

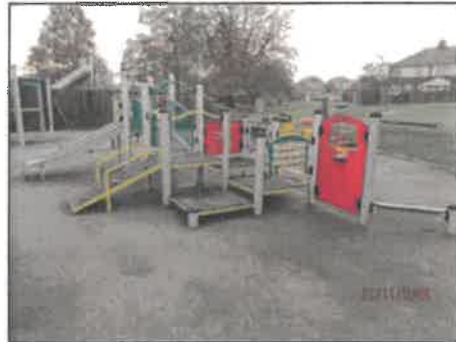
8. Sutcliffe Toddler Multi Unit

Condition: Centre disc on play panel missing – monitor

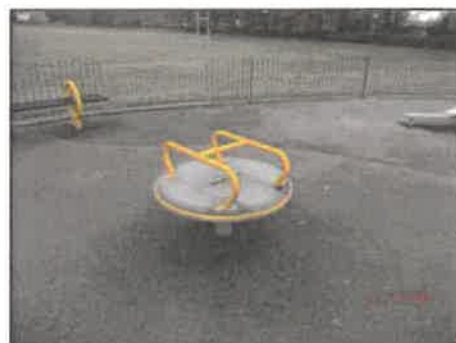
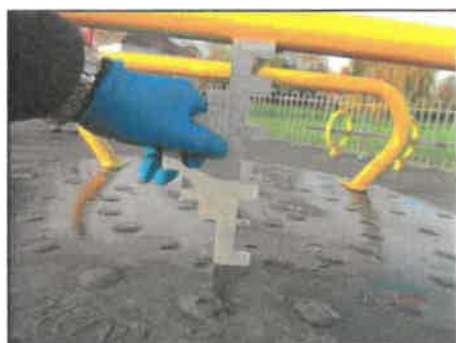
10. Sutcliffe Roundabout

Compliance: Fails BS EN 1176-1, Sec. 4.2.7.2, head trap between frame & platform

(Potential head trap – library photo)

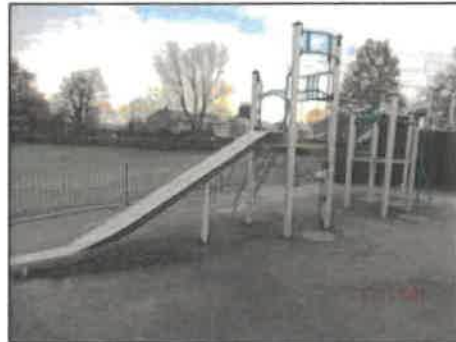
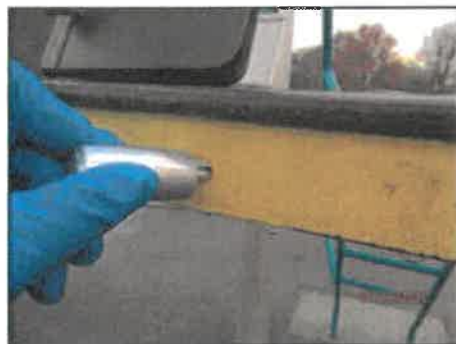
11. Sutcliffe Junior Multi Unit

Condition: Replace two missing bolts on side of platform

Compliance: Fails BS EN 1176-1, Sec. 4.2.7.6, potential finger traps at holes on platform where bolts missing

(Potential finger traps at missing bolts)

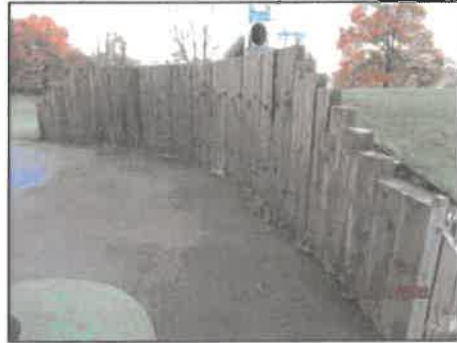
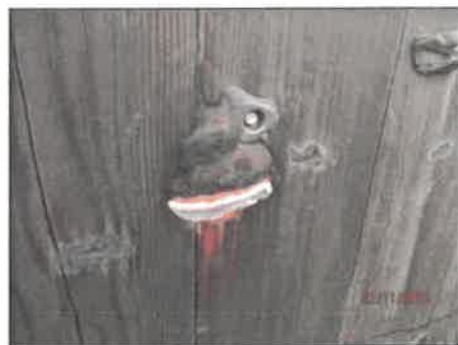
14. Bespoke Traverse Wall

Condition: Slight rotting of logs – monitor

(Rotting log)

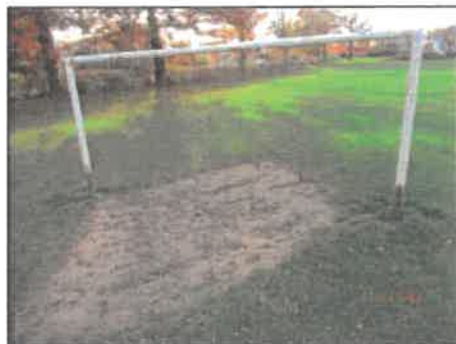
15. Unknown Make One 5-a-side Goal

Surface Condition: Worn – monitor

(Library photo)

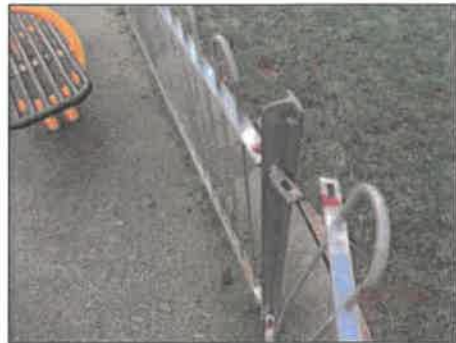
- Seats x three – within 1m of fence (**Low Risk**)
- Litter Bin x one – satisfactory (**Very Low Risk**)
- Sign – satisfactory (**Very Low Risk**)
- Fence (around items 6-14 only) – potential neck trap at bow tops & seat within 1m (**Medium Risk**) Anti-sag bars not fitted – monitor. Replace one missing bolt
- Pedestrian Gate x one – clearance of between 60mm & 110mm should be maintained at bottom of gate (actually 45mm) (**Low Risk**)
- Only one pedestrian entrance (**Medium Risk**)
- Path satisfactory (**Very Low Risk**)
- General area – good condition. Tidy

(Missing fence bolt)

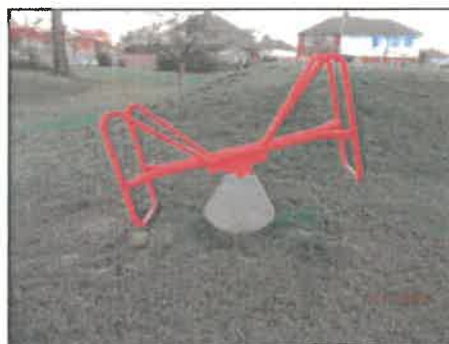
2. Sutcliffe Stand-on Seesaw

Condition: Excessive movement in foundations – requires attention

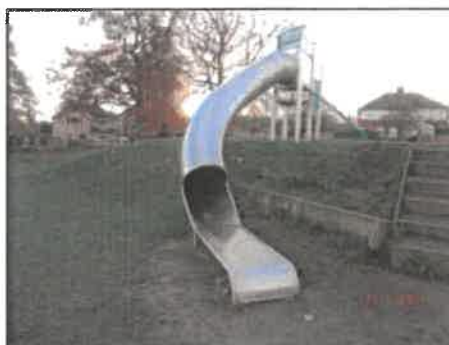
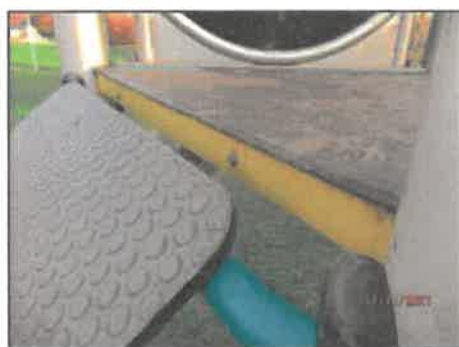
3. Sutcliffe Tube Slide

Compliance: Fails BS EN 1176-1, Sec. 4.2.7.5, foot trap between platform & top of incline climber

(Potential foot trap)

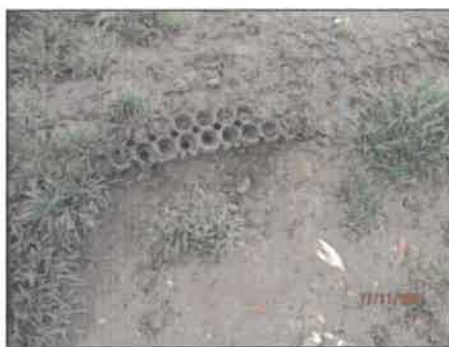
Surface Condition: Potential trip hazards at edges of mats – requires attention (Medium Risk)

(Potential trip hazard at edge of mat)

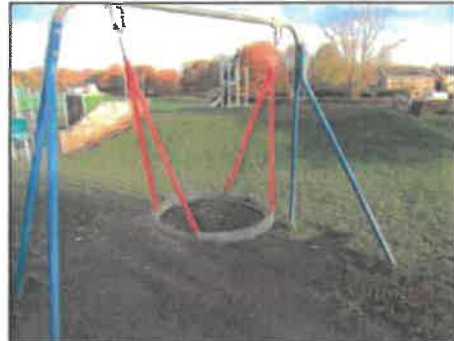
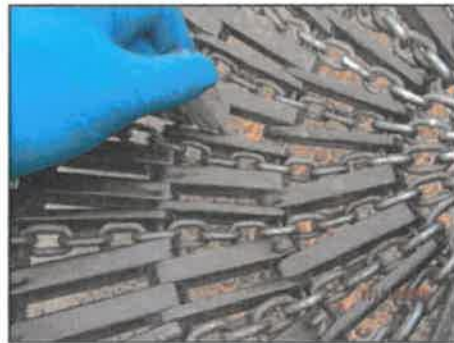
4. Sutcliffe Group Swing

Compliance: Fails BS EN 1176-1, Sec. 4.2.7.6, finger trap between plastic links on basket

Surface Condition: Grass worn (impact attenuating properties impaired if not well maintained) – requires attention

(Potential finger trap)

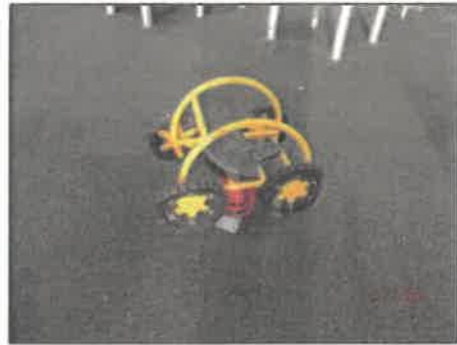
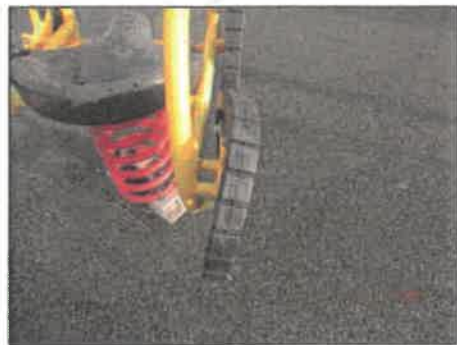
6. Sutcliffe Spring Car

Condition: Slight distortion on one wheel – monitor

(Distorted wheel)

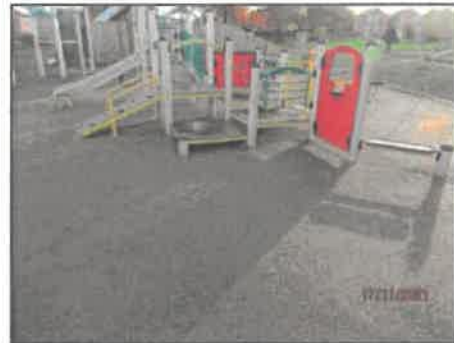
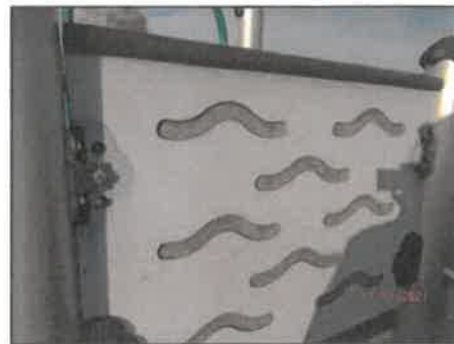
8. Sutcliffe Toddler Multi Unit

Condition: Centre disc on play panel missing – monitor

(Missing bolt cover caps)

Replace two missing bolt cover caps

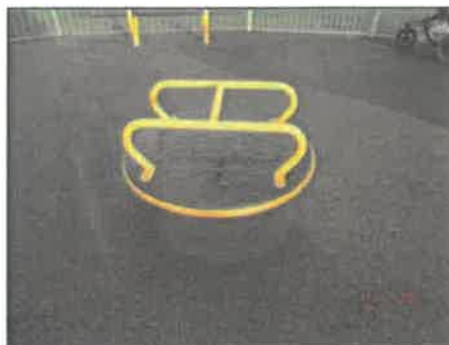
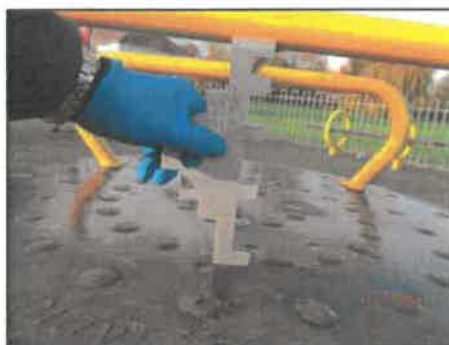
10. Sutcliffe Roundabout

Compliance: Fails BS EN 1176-1, Sec. 4.2.7.2, head trap between frame & platform

(Potential head trap)

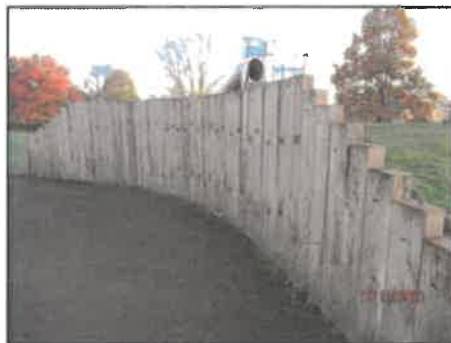
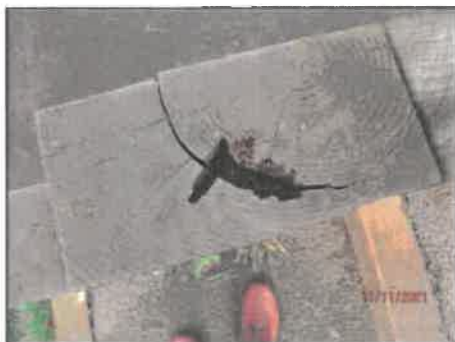
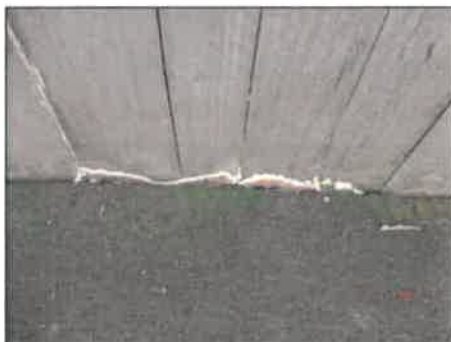
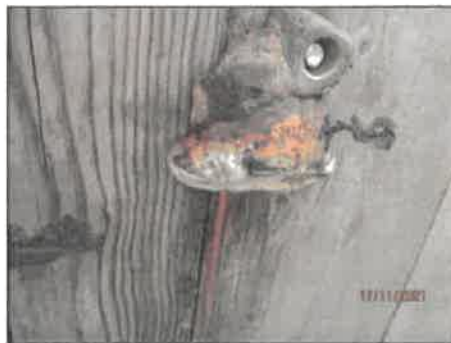
14. Bespoke Traverse Wall

Condition: Slight rotting of logs – monitor

(Rotting log)
