**Freedom of Information Request – Low Ackworth Playground Gate**

## BELL LANE

Date of inspection:-

**7/12/2023**

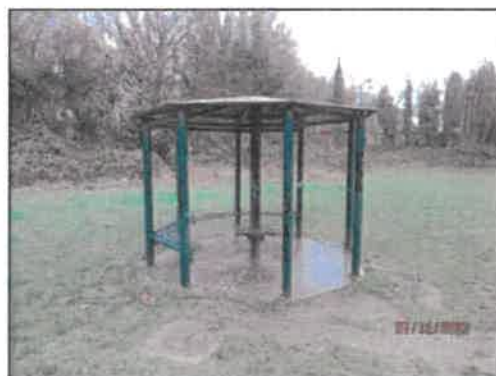
### **1. Lightmain Teen Shelter**

**Condition:** No defects were found

**Surface Condition:** Worn

**Low Risk: 6**

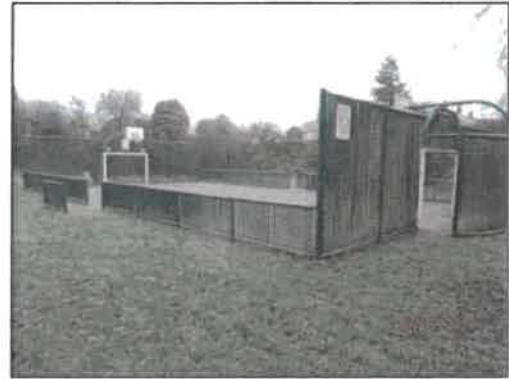
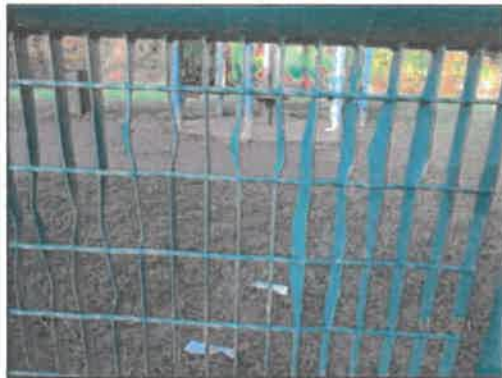
### 2. Lightmain Multi-use Games Area

**Condition:** Slight damage to one mesh panel – monitor  
Slight fire-damage to one panel – monitor

**Medium Risk: 8**

(Slight damage to mesh panel – library photo)

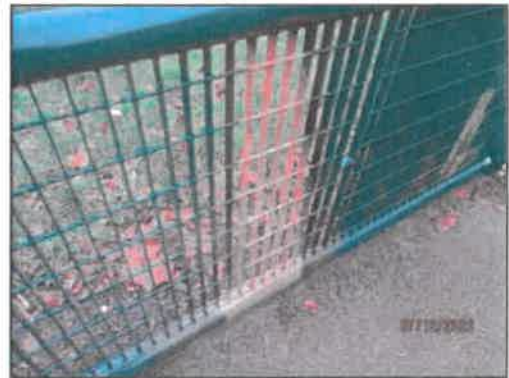
(Slight fire-damage to panel)

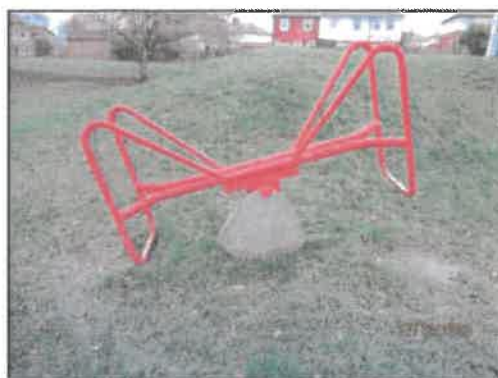
### 2. Sutcliffe Stand-on Seesaw

**Condition:** Excessive movement in foundations – requires attention

**Low Risk: 6**

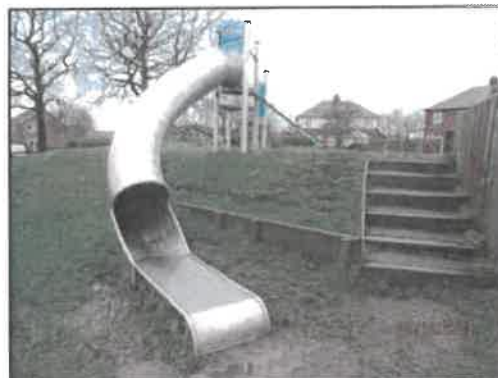
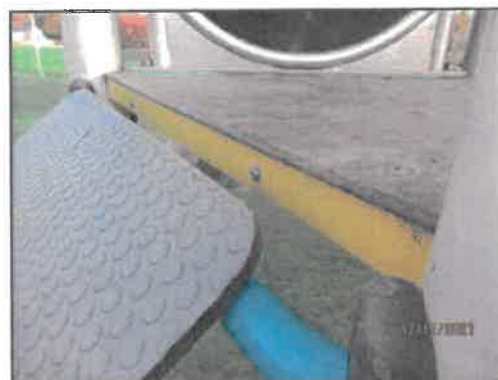
### 3. Sutcliffe Tube Slide

**Compliance:** BS EN 1176-1, Sec. 4.2.7.5, potential foot trap between platform & top of incline climber

**Low Risk: 7**

(Potential foot trap – library photo)

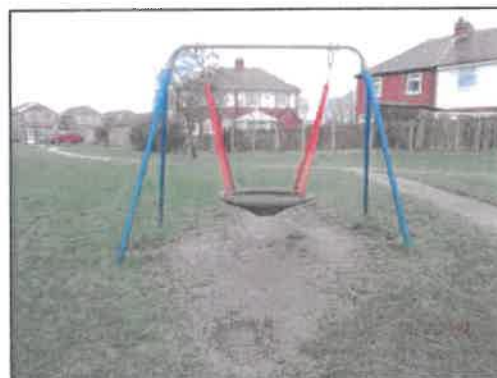
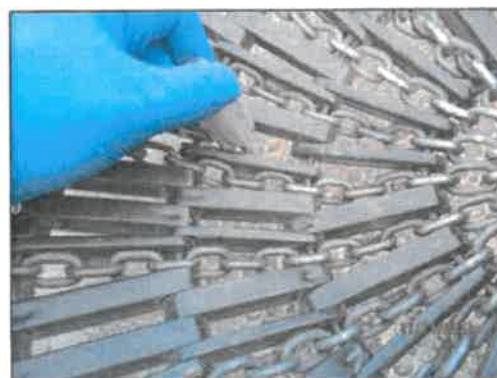
### 4. Sutcliffe Group Swing

**Compliance:** BS EN 1176-1, Sec. 4.2.7.6, potential finger trap between plastic links on basket

**Surface Condition:** Grass worn (this may affect the impact attenuating properties of the mats)

**Low Risk: 7**

(Potential finger trap – library photo)

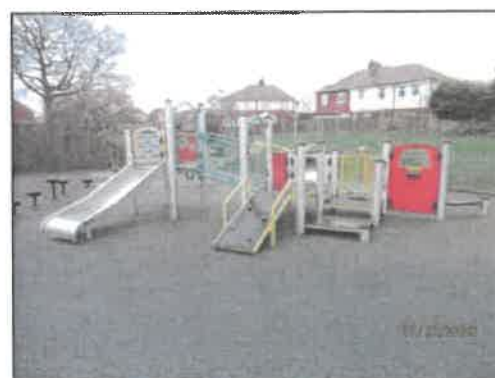
### 8. Sutcliffe Toddler Multi Unit

**Condition:** Centre disc on play panel missing – monitor

**Low Risk: 4**

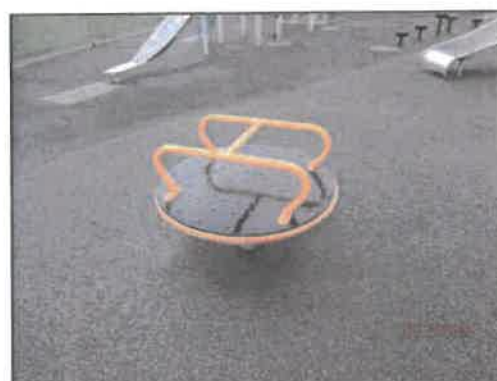
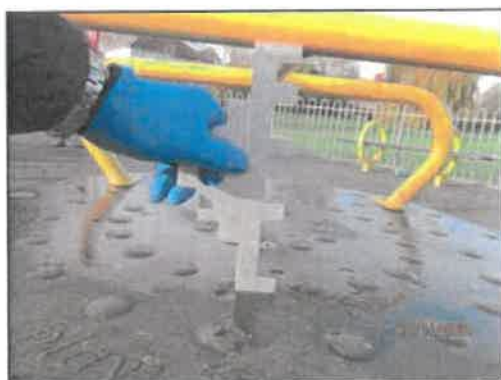
### 10. Sutcliffe Roundabout

**Compliance:** BS EN 1176-1, Sec. 4.2.7.2, potential head trap between frame & platform

**Low Risk: 5**

(Potential head trap – library photo)

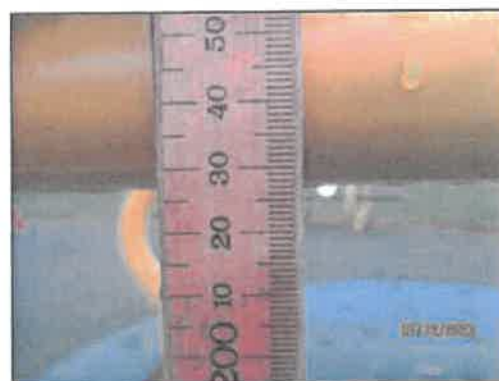
(Potential head trap)

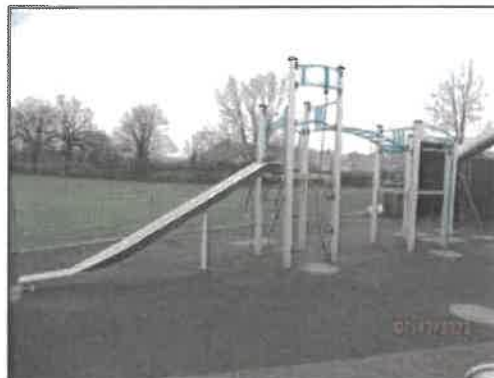
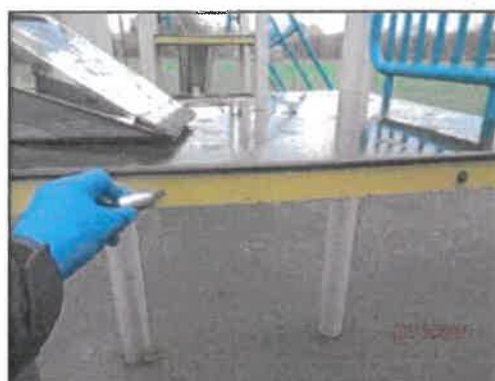
### 11. Sutcliffe Junior Multi Unit

**Compliance:** BS EN 1176-1, Sec. 4.2.7.6, potential finger traps at holes on platform where bolts missing

**Medium Risk: 12**

(Potential finger trap at missing bolt)

**Condition:** Replace missing bolt on side of platform

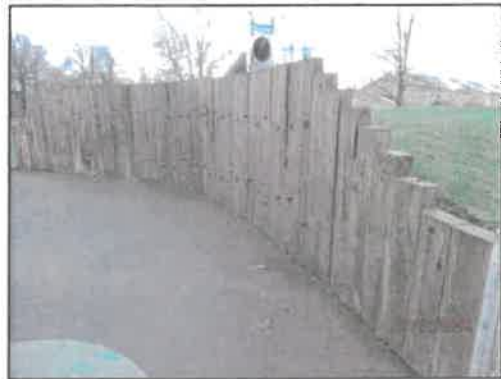
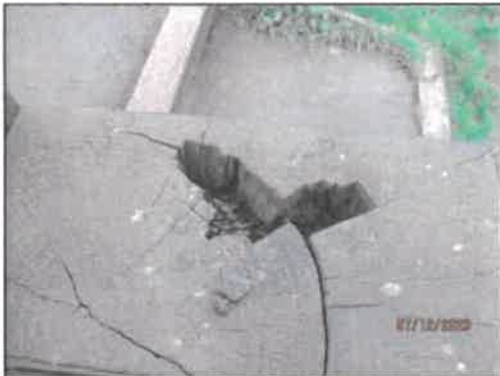
### 14. Bespoke Traverse Wall

**Condition:** Slight rotting of logs – monitor  
Resecure two loose foot holds

**Low Risk: 4**

(Rotting log)

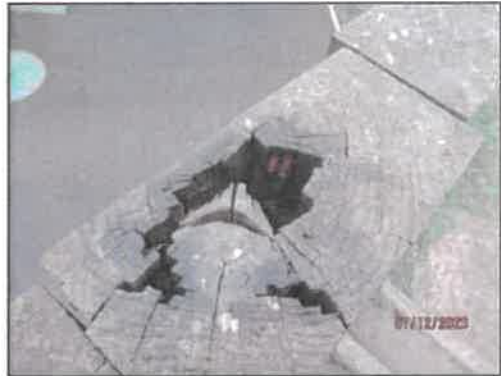
(Rotting log)

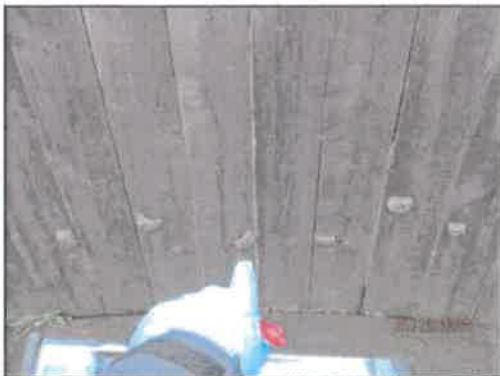
(Loose foot hold)

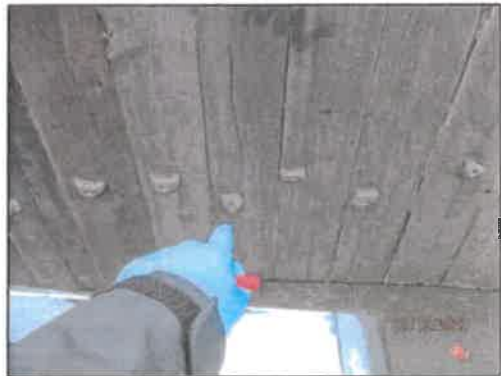
(Loose foot hold)

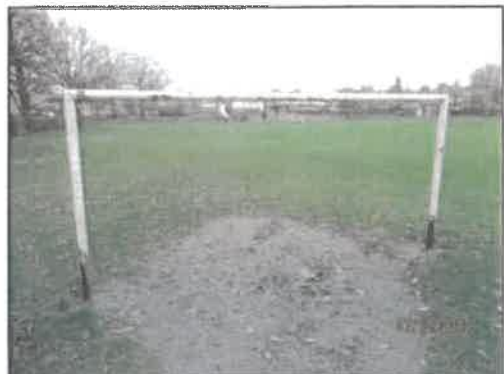
### 15. Unknown Make One 5-a-side Goal

**Surface Condition:** Worn – monitor  
Glass present in goal – remove

**Medium Risk: 8**

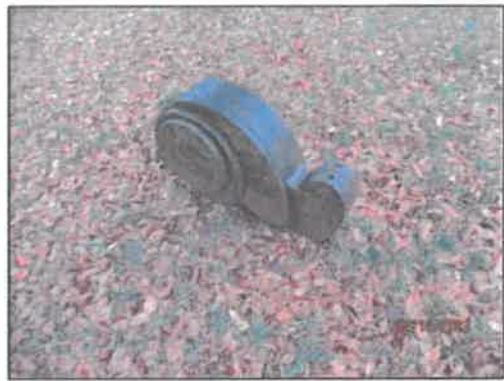
### 4. Handmade Places Snail

**Condition:** Hand holds missing – monitor

**Surface Condition:** Showing signs of wear

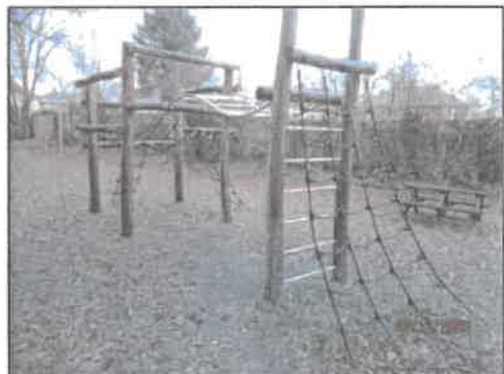
### 6. Norleg Multi Climbing Frame

**Condition:** Small splits in logs – monitor

**Low Risk: 7**

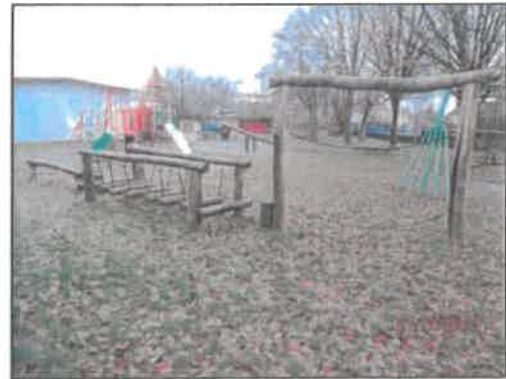
### 7. Norleg Four-item Trim Trail consisting of:

**Condition:** Small splits in logs – monitor

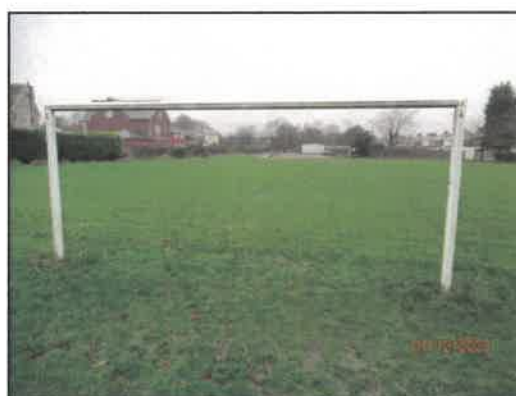
### 11. Harrod Two Goals

**Surface Condition:** Showing signs of wear in one goal –  
monitor

**Medium Risk: 8**
