Freedom of Information Request – Low Ackworth Playground Gate

BELL LANE

CARR BRIDGE PLAYING FIELD

LOW ACKWORTH PLAYING FIELD

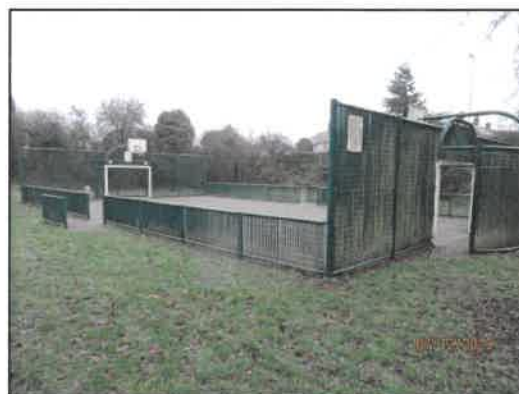
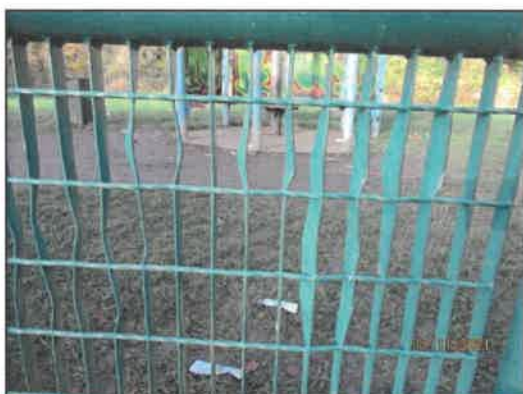
Condition: Slight damage to one mesh panel – monitor
Slight fire-damage to one panel – monitor

(Slight damage to mesh panel – library photo)

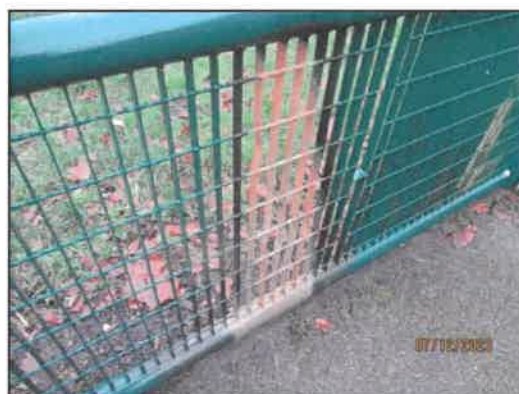
(Slight fire-damage to panel)

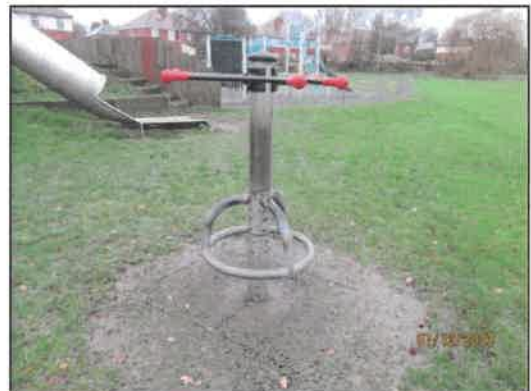
2. Sutcliffe Stand-on Seesaw

Condition: Excessive movement in foundations – requires attention

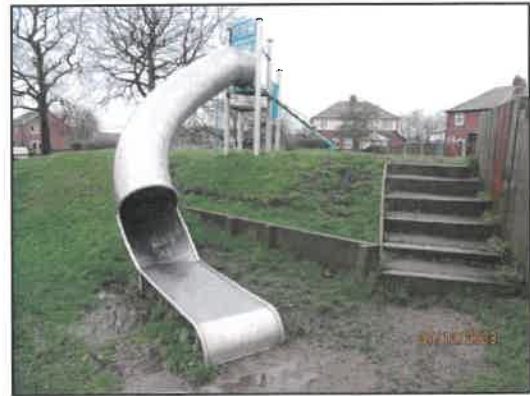
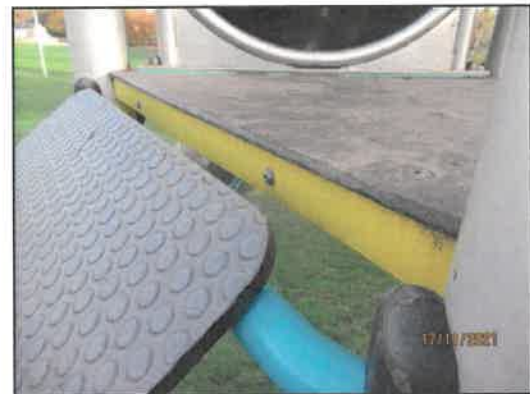
Compliance: BS EN 1176-1, Sec. 4.2.7.5, potential foot trap between platform & top of incline climber

(Potential foot trap – library photo)

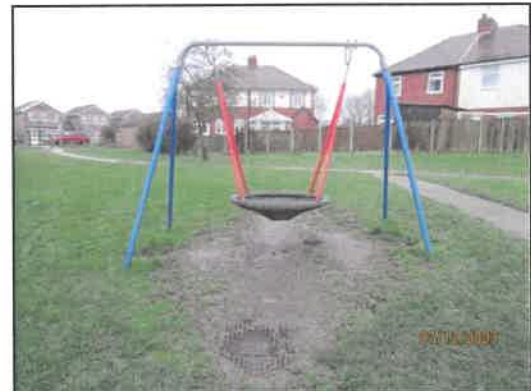
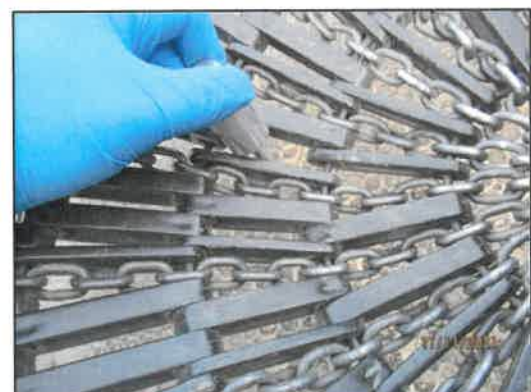
Compliance: BS EN 1176-1, Sec. 4.2.7.6, potential finger trap between plastic links on basket

Surface Condition: Grass worn (this may affect the impact attenuating properties of the mats)

(Potential finger trap – library photo)

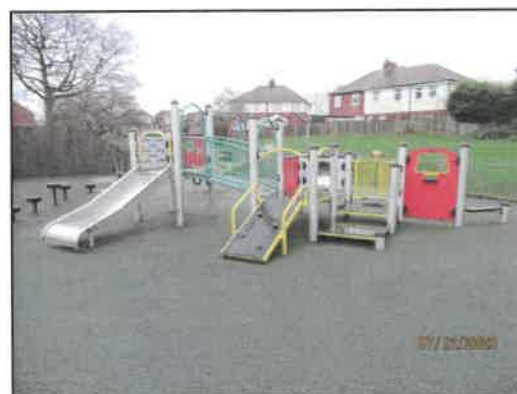
8. Sutcliffe Toddler Multi Unit

Condition: Centre disc on play panel missing – monitor

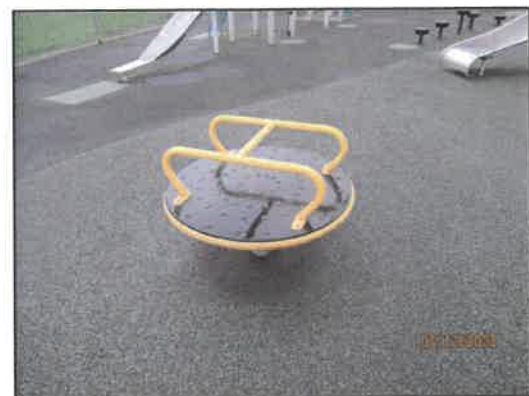
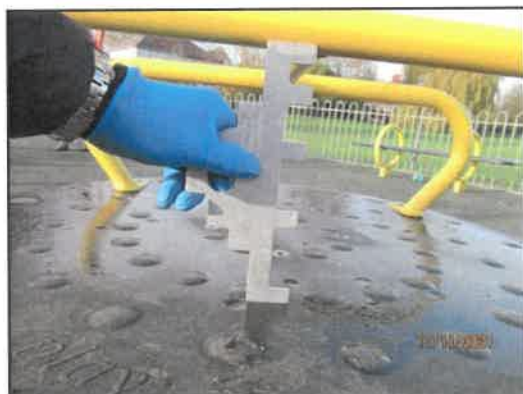
Compliance: BS EN 1176-1, Sec. 4.2.7.2, potential head trap between frame & platform

(Potential head trap – library photo)

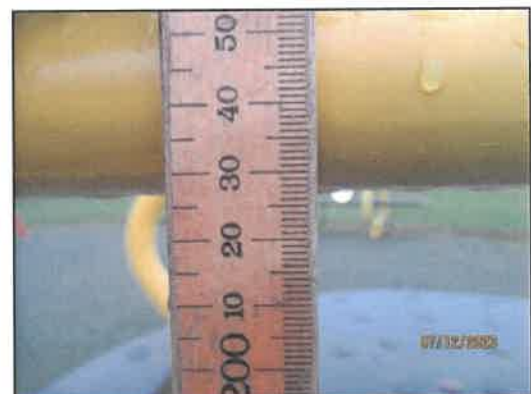
(Potential head trap)

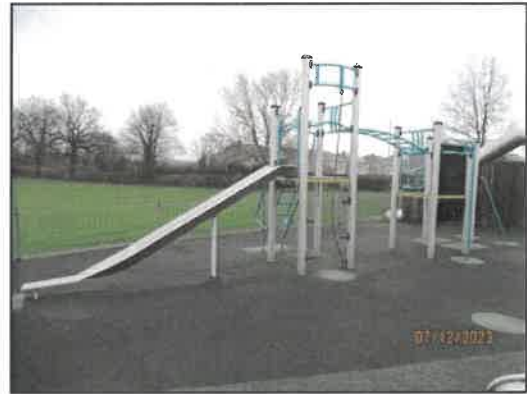
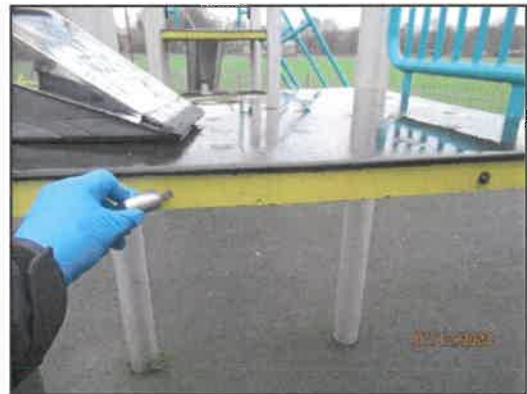
Condition: Replace missing bolt on side of platform

Compliance: BS EN 1176-1, Sec. 4.2.7.6, potential finger traps at holes on platform where bolts missing

(Potential finger trap at missing bolt)

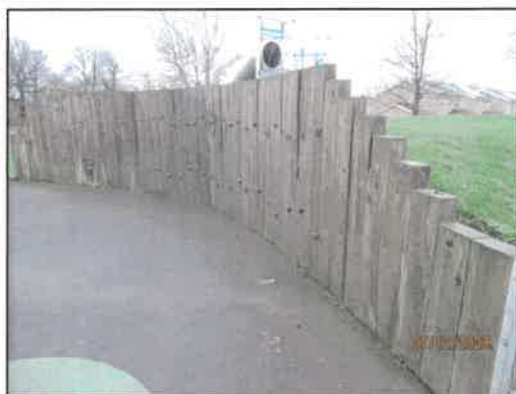
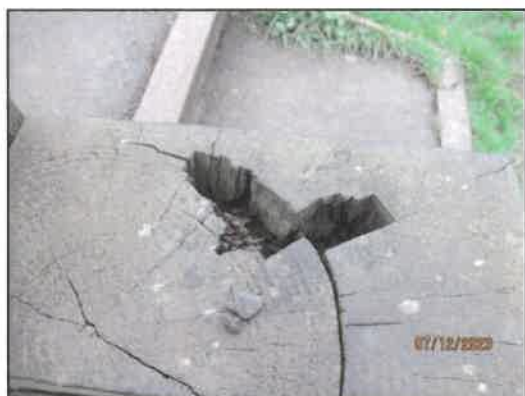
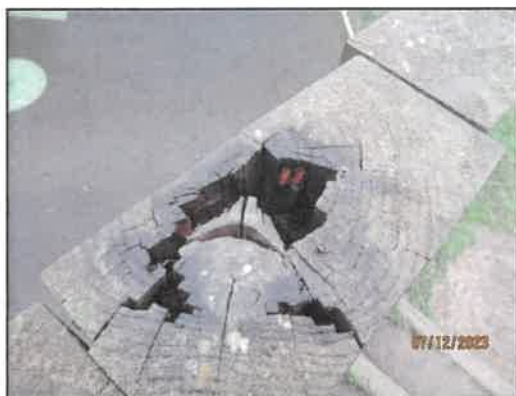
Condition: Slight rotting of logs – monitor
Resecure two loose foot holds

(Rotting log)

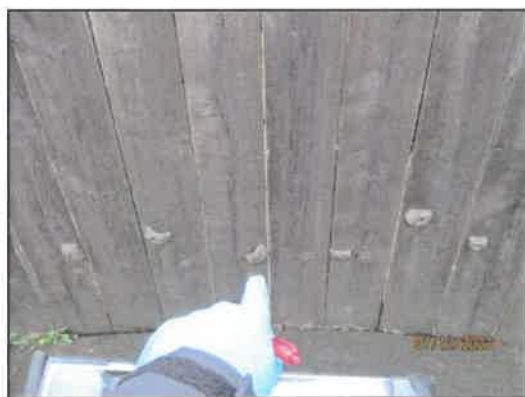
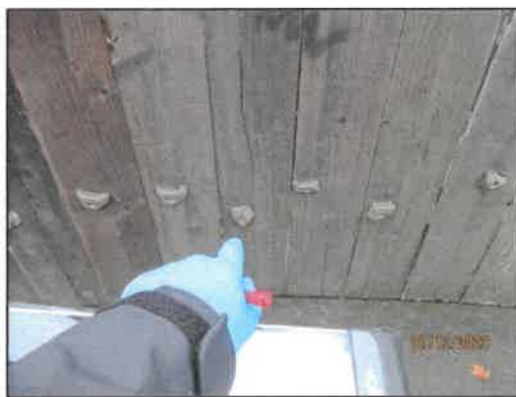
(Loose foot hold)

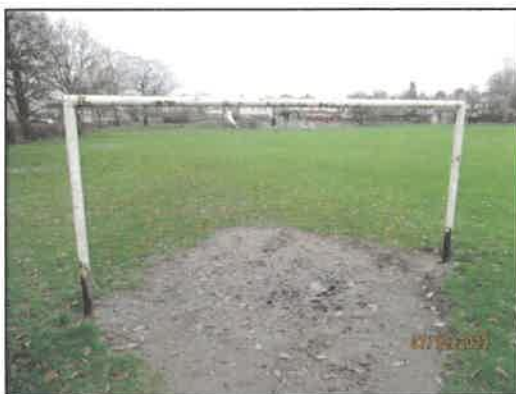
15. Unknown Make One 5-a-side Goal

Surface Condition: Worn – monitor

Glass present in goal – remove

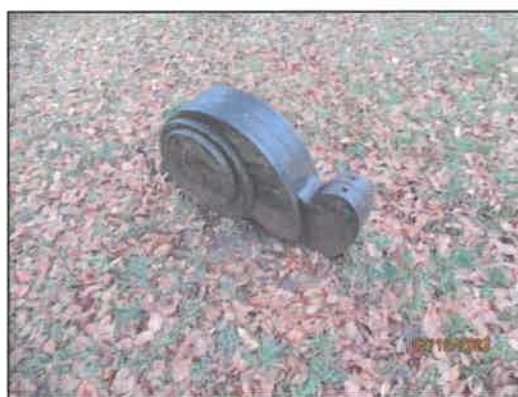
4. Handmade Places Snail

Condition: Hand holds missing – monitor

Surface Condition: Showing signs of wear

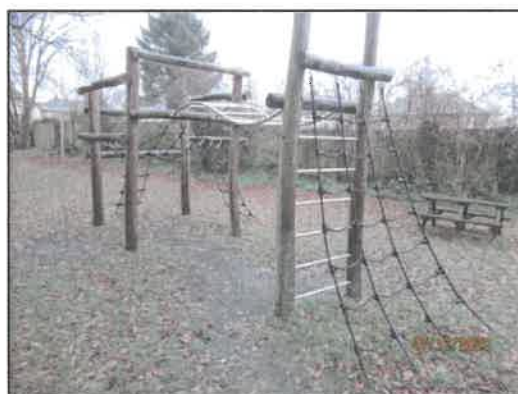
6. Norleg Multi Climbing Frame

Condition: Small splits in logs – monitor

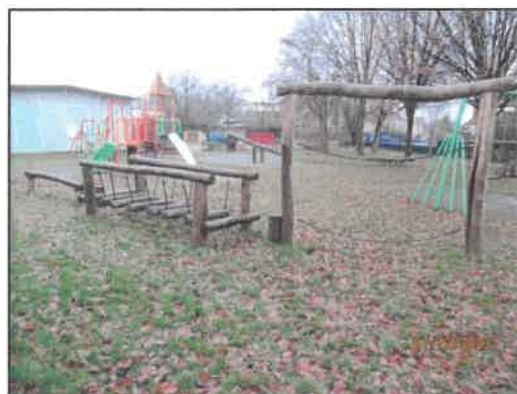
7. Norleg Four-item Trim Trail consisting of:

Condition: Small splits in logs – monitor
