**Freedom of Information Request – Low Ackworth Playground Gate**

## BELL LANE

Date of inspection:-

**7/12/2023**

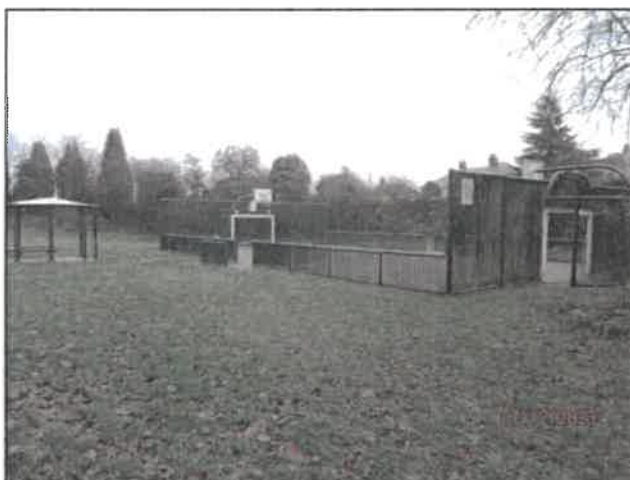
### **1. Lightmain Teen Shelter**

**Condition:** No defects were found

**Surface Condition:** Worn

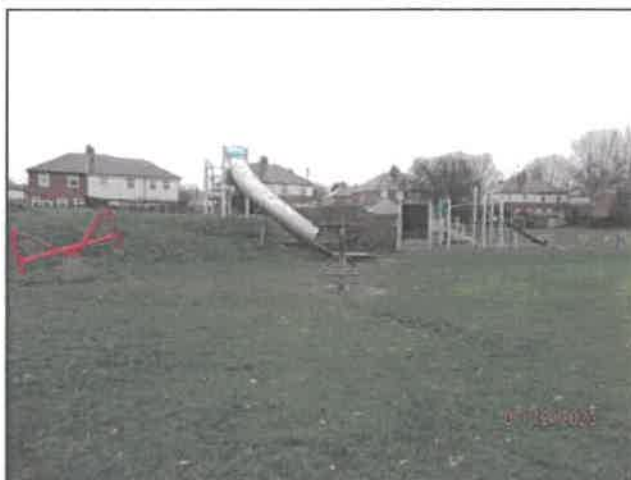
### 1. Sutcliffe Rota Item

**Condition:** No defects were found

**Surface Condition:** Satisfactory

**Low Risk: 4**

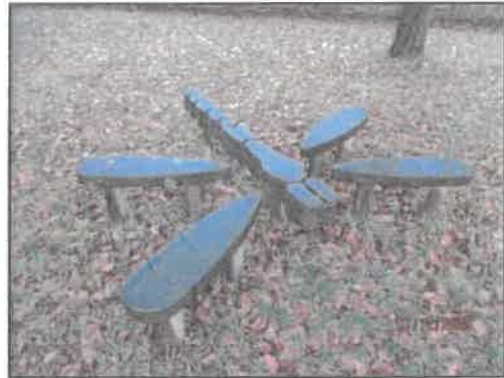
### 4. Handmade Places Snail

**Condition:** Hand holds missing – monitor

**Surface Condition:** Showing signs of wear

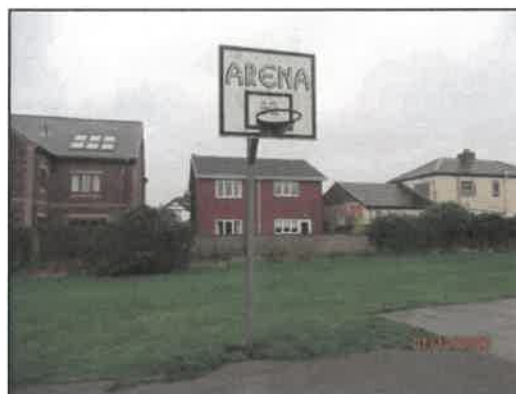
### 11. Harrod Two Goals

**Condition:** No defects were found

**Surface Condition:** Showing signs of wear in one goal –  
monitor
